Re: February 2018 Monthly Progress Report  
Administrative Settlement Agreement and Order on Consent for Removal Action  
USEPA Region 10 Docket No. CERCLA 10-2009-0255  
Gasco Sediments Site within the Portland Harbor Superfund Site

Attachment A Monthly Visual Monitoring Report for Pilot Cap Vicinity

# Visual Observations Log Form

**Project:** NW Natural – Gasco Sediments

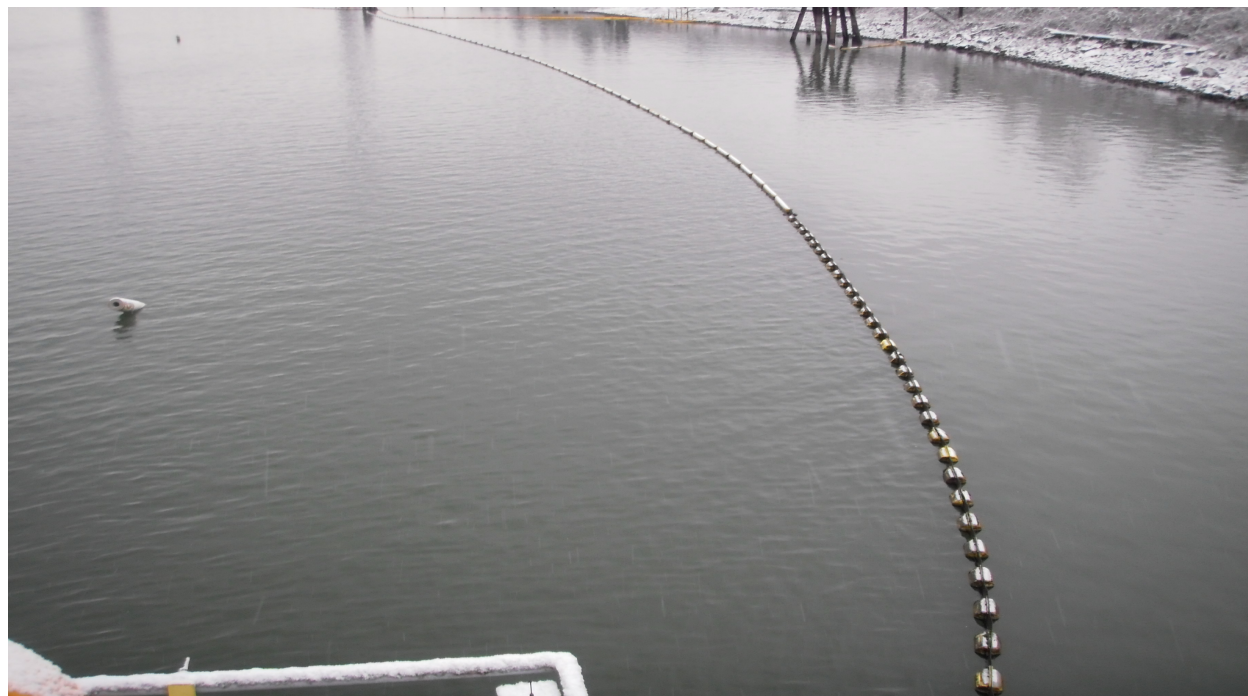
**Photo 1**

During the observation, the FAMM containment boom was placed across the cap area from the ship dock to the upriver dolphin. One buoy that identifies the cap area to mariners is in place as installed. The positions of the FAMM oil boom and warning buoy are shown in Photo 1.

**FAMM Oil Boom Placement and Mariner Warning Buoy at Pilot Cap Area (2/20/2018)**

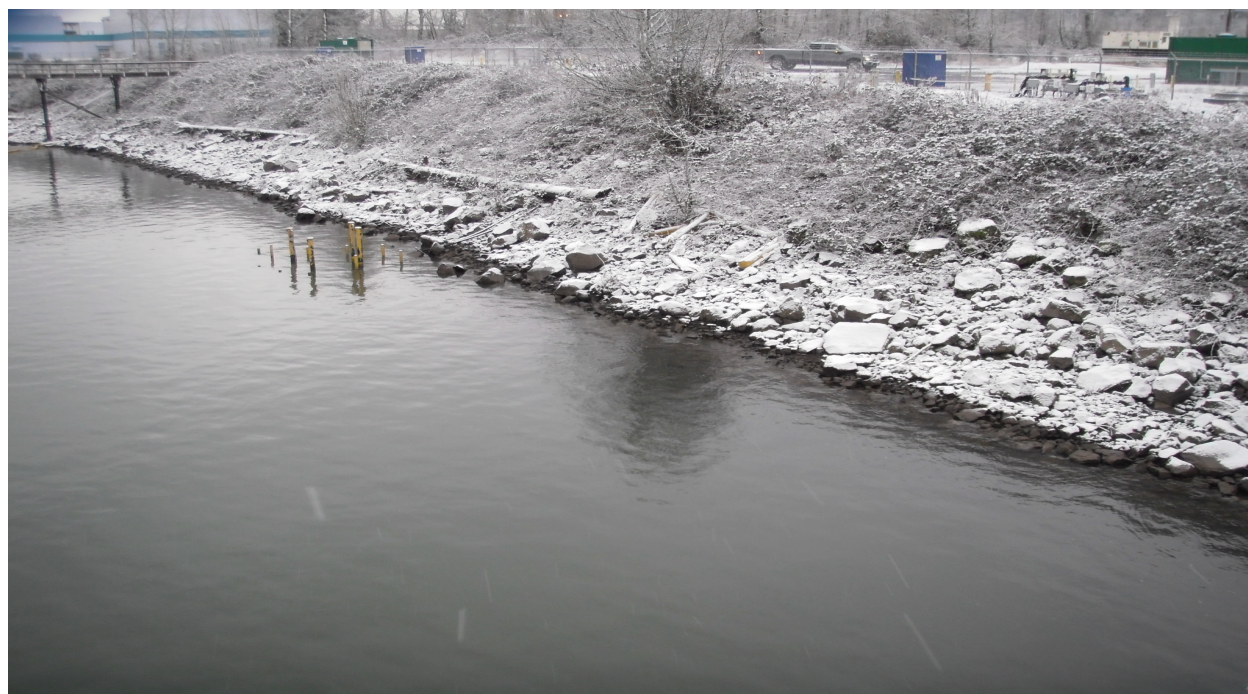
**Photo 2**

The shoreward extent of the cap was not visible due to high river water elevation and the organoclay mat material shoreward of the cap area could not be observed (Photo 2).

**River Level Currently Above the Extent of Sediment Cap (2/20/2018)**

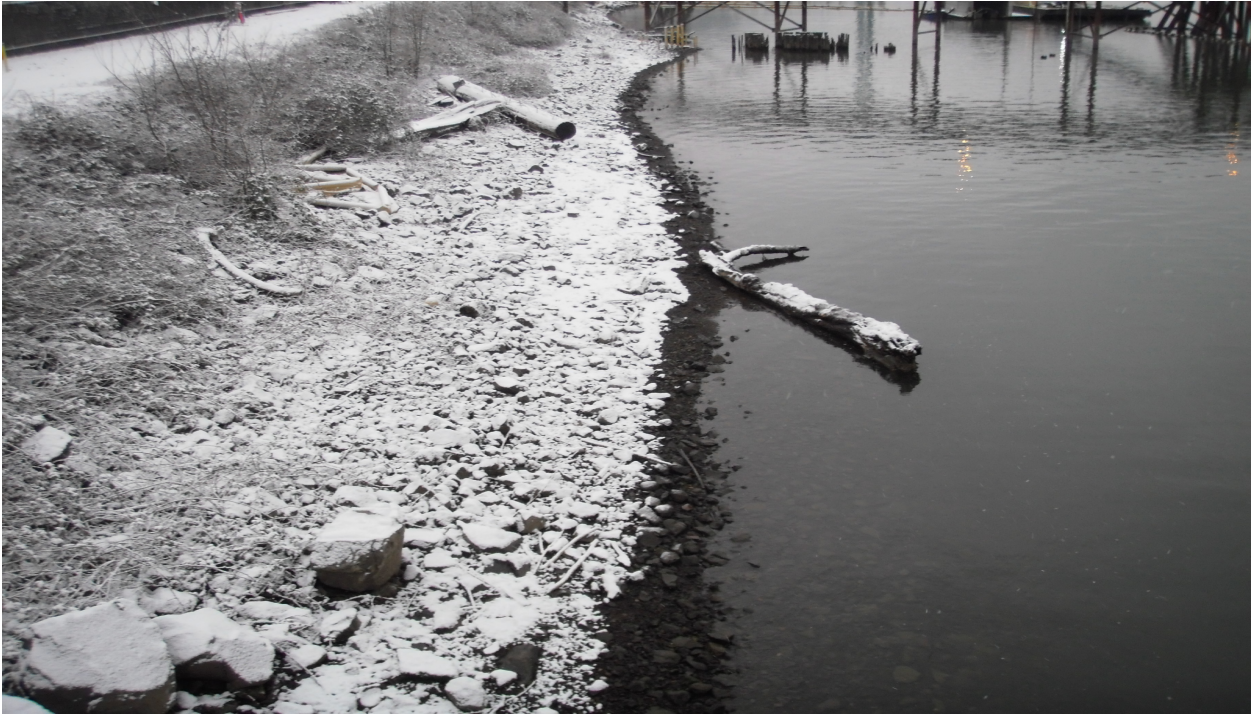
**Photo 3**

No sheen is evident in or around the cap area. Photo 3 shows the water surface and shoreline immediately downriver of the sediment cap.

**Conditions Immediately Downriver of Cap Area (2/20/2018)**
